SENDJE CEIBA FPSO PROTECTED BY DEEPWATER'S RETROBUOY™: EQUATORIAL GUINEA/EQUATORIAL GUINEA

Deepwater was contracted to upgrade the FPSO's cathodic protection system for a 20-year life extension.

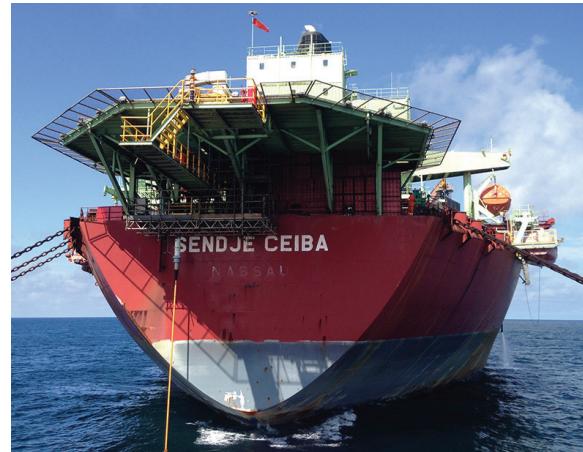
RUNNING LOW ON CATHODIC PROTECTION
The original anodes on the FPSO were nearly depleted.

Data from surveys in 2007, 2011 and 2013 indicated the sacrificial anodes were nearly depleted and were still depleting at a constant rate. A preliminary engineering analysis estimated a retrofit would be required by 2016 (9 years from the time of the 2007 survey) to prevent the asset from depolarizing towards unprotected potentials. A seabed-mounted ICCP system was chosen from the technically feasible solutions as the most cost-effective and most efficient. One of the key decisions in this process was the anchoring configuration of the FPSO.

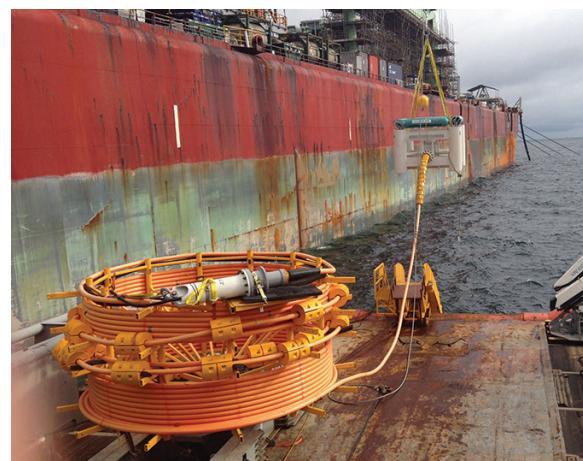
RAPID INSTALLATION
The RetroBuoy™ is lowered into a specific placement and orientation

The CP retrofit system installed on the FPSO near Equatorial Guinea is a single RetroBuoy™ with four individual floats, each containing three anodes for a total of 12 anodes working in parallel. The power supply is a single TR unit located topside. The anode and power supply are connected by a single run of multi-core subsea anode power cable routed from the anode sled through the riser support structure to the riser gantry, and interconnecting DC positive cables between the TR unit and the hang-off point. The circuit is completed using a negative drain box and associated cable connecting the TR negative output to the structure. The power cable was deployed with a lazy wave configuration to accommodate the movement of the vessel. This single subsea anode unit and the associated topside equipment replaces the FPSO's original 332 zinc anodes.

Prior to deployment, the cable was spooled onto a horizontal drum and the buoyancy modules were attached. The subsea power cable was pre-attached to the anode module and lifted as a single piece onto to the ROV support vessel ready for installation.

A messenger wire from the FPSO winch was lowered down to the water line and with assistance from the support vessel, the winch wire was transferred to the back deck of the support. The winch wire was then securely attached to the pad eye at the top of the pulling head. The pulling head was deployed subsea and pulled through the hang-off porch and secured into the split flange.

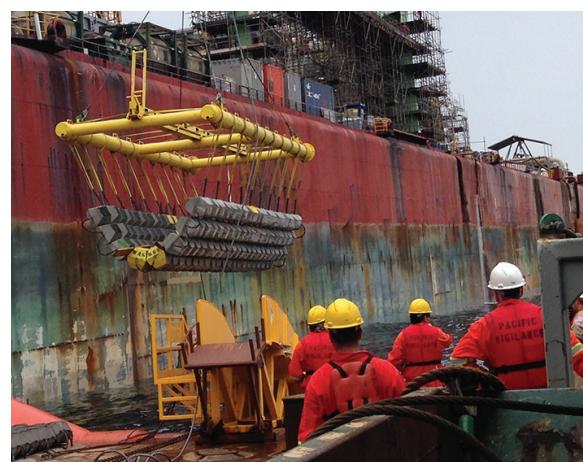
STAYING IN PLACE
A concrete mat keeps the cable in place on the sea floor.

Once the cable was fully deployed, a concrete stabilization mattress was added near the touchdown location to minimize cable walking.
